wisconsin remodeler awards

Disaster Restoration, Fire | Historic Building

Bourbon & Tunns Tavern | Milwaukee, WI

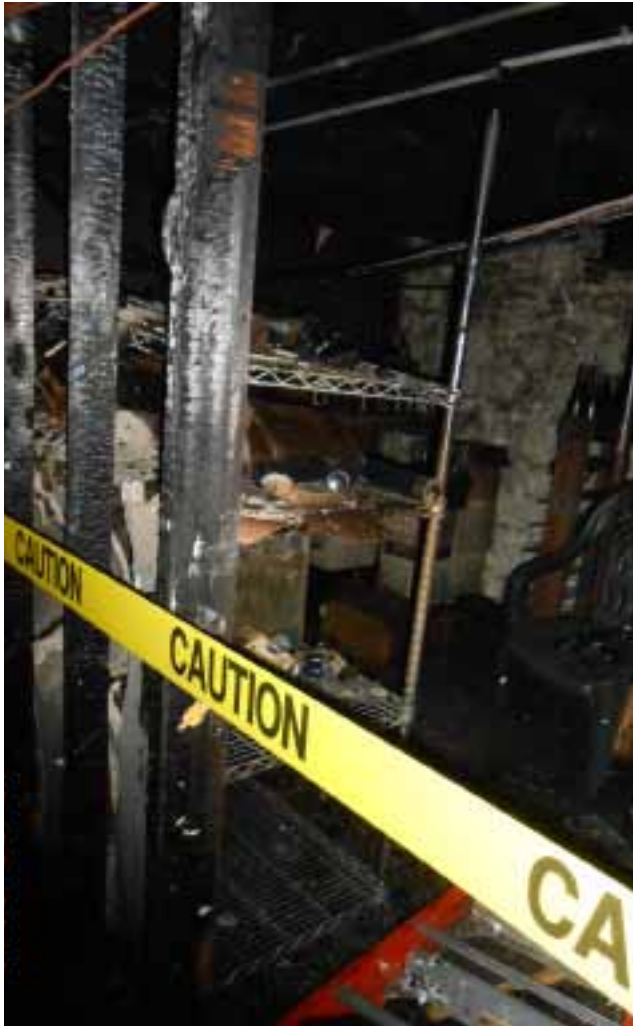
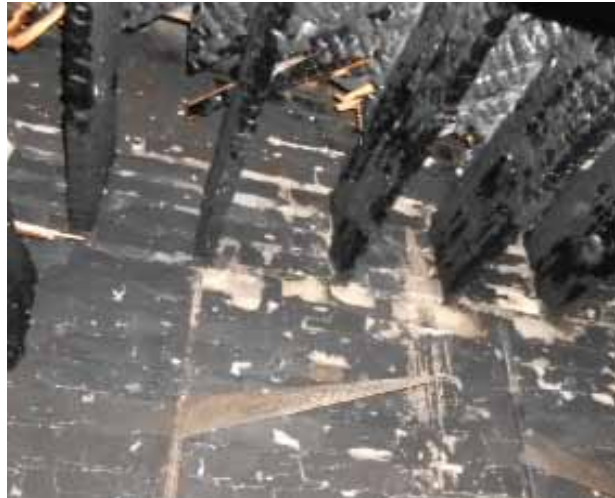
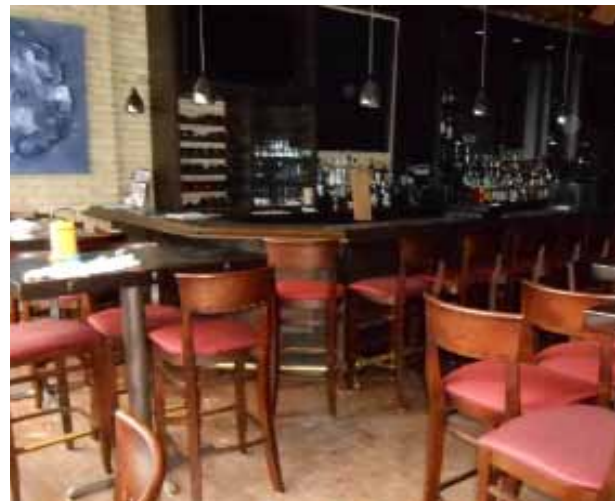
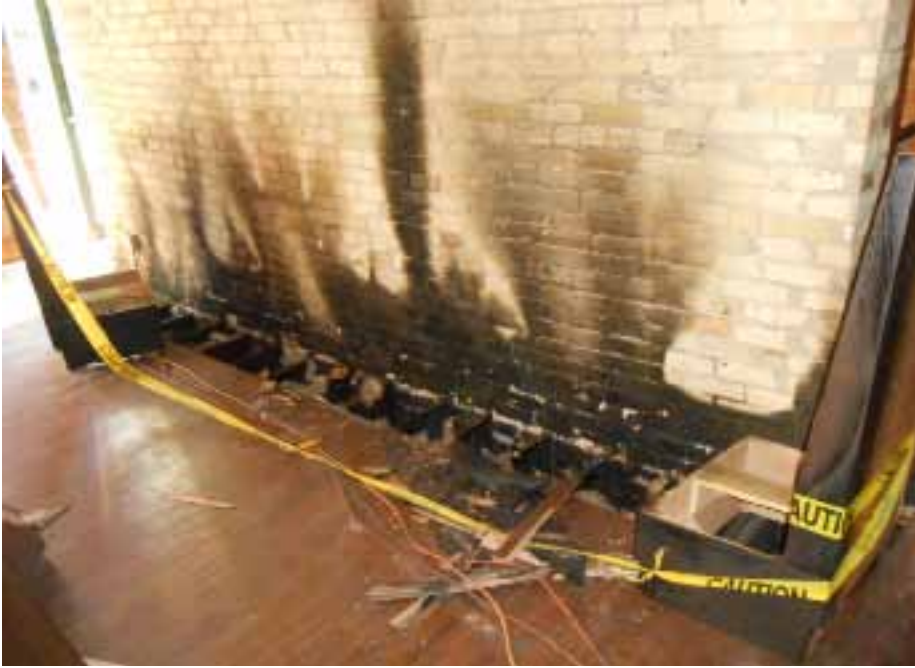
The three-story bar, restaurant, banquet hall, kitchen and basement of the Bourbon & Tunns Tavern located in a historic 1895 cream city brick building was severely damaged by a late night chemical fire in the basement.

This fire burned for 30 minutes, an extremely long time. There was not a source of ventilation created in the structure so the fire smoldered throughout the 7,860 square foot building making the smoke odor removal more complex, especially given the age of the property.

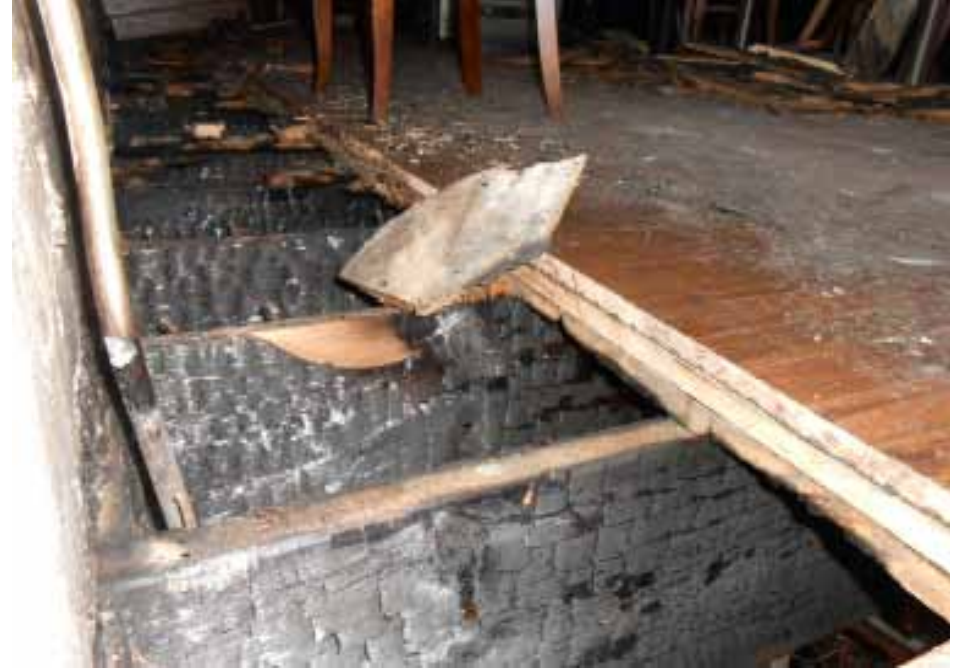
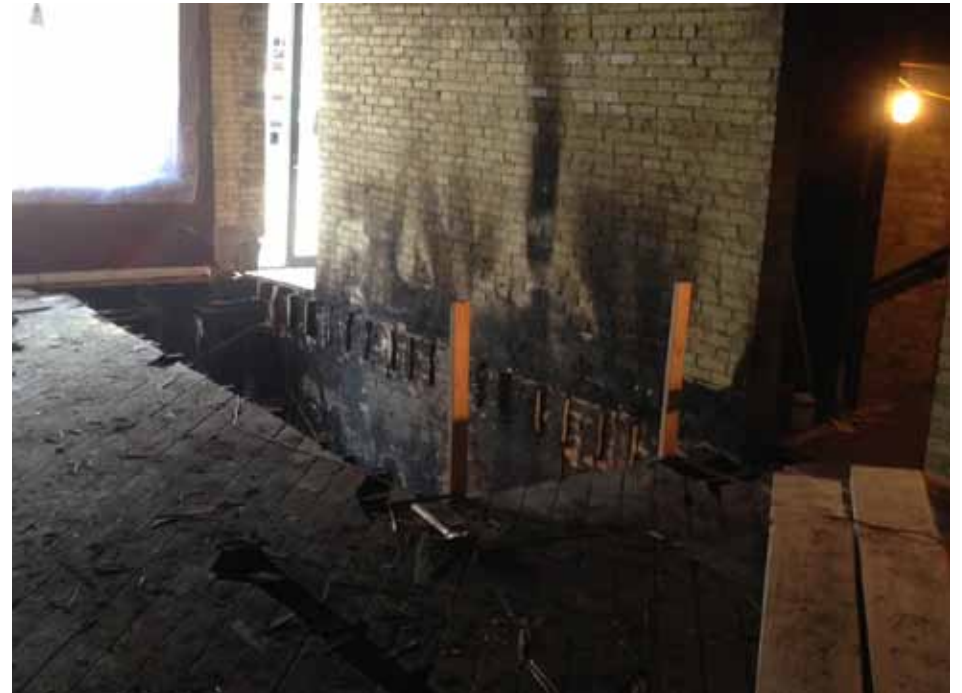
Dining Room:

Two layers of sub floor starting with a maple layer, then finished with oak, helped prevent the flames from jumping to the first floor. The two floors above the basement were heavily damaged by soot and odor traveling through the HVAC system.

The fire severely compromised the dining room floor joists. Notice the extremely charred joists, 32 in total, that were impacted by the fire.

The hole pictured to the right was creatively used to lower the new 20 ft steel I-beam and floor joists down so we could systematically replace joist by joist. Schedule considerations were important throughout the project, especially with beams and joists that were trailored in on the MLK holiday to avoid downtown traffic and pedestrians in this historic business district.

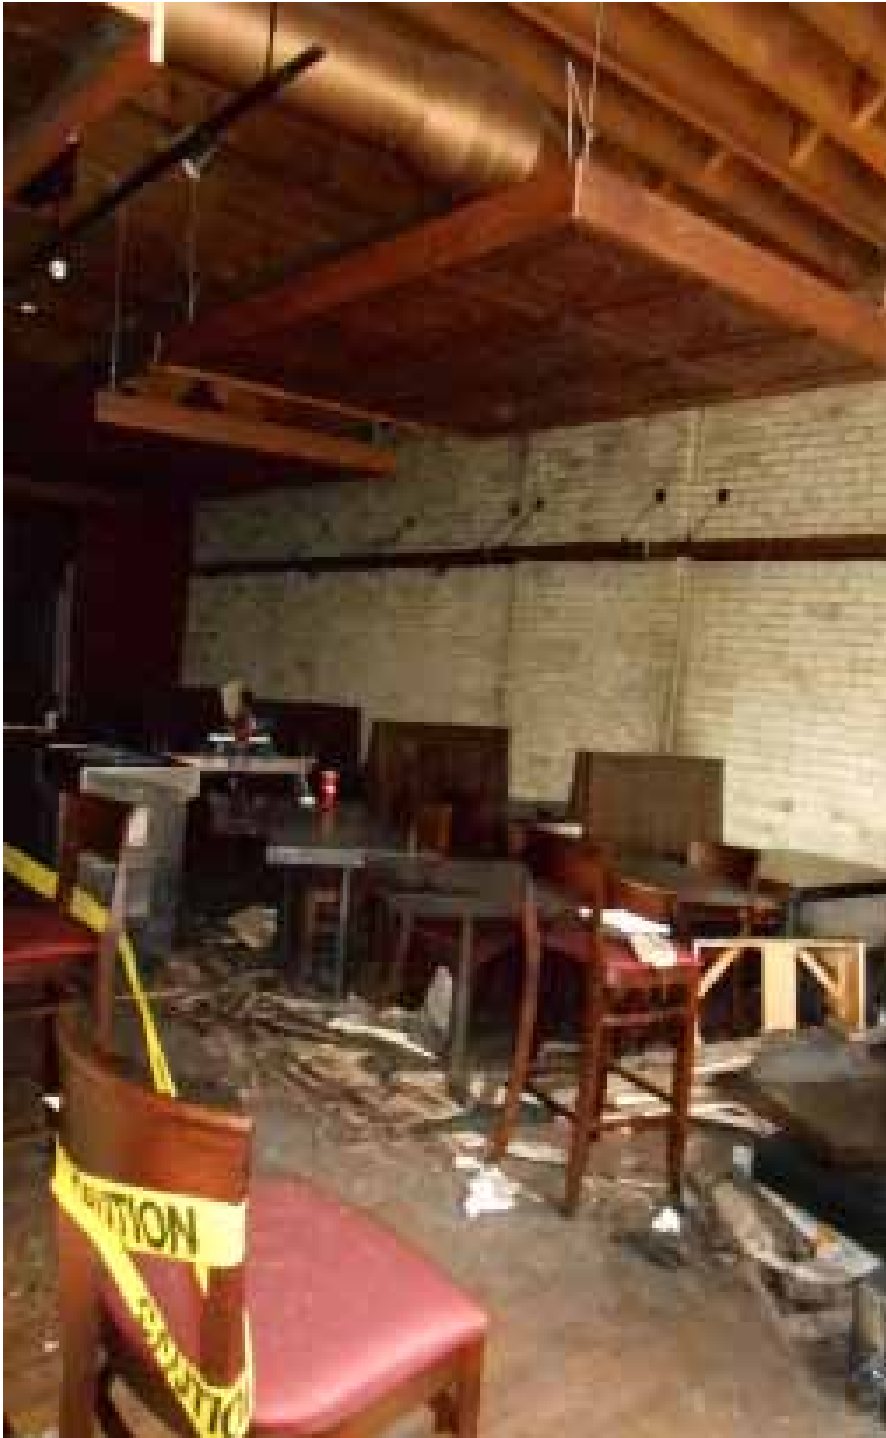
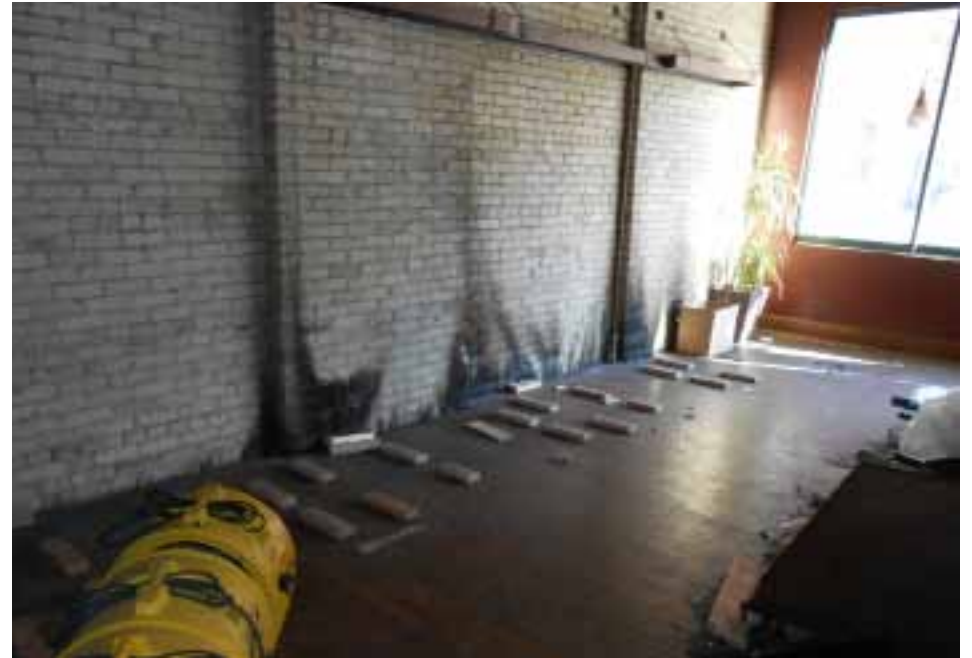
After: Same angle from the top left and bottom right pictures above.

Detail and custom craftsmanship were important to the owner and add to the aesthetics and function of the dining room.

- Lighting and crown molding were added to the floating “clouds” above the dining tables.
- Track lighting was incorporated on wall shelves to highlight an expansive wine collection.
- Decorative trim was scribed to avoid gaps in the booths.
- Shoe molding and mop rails were added to ease cleaning and for health reasons.
- Oak flooring was seamlessly matched to original quality and not show any sign of replacement or fire damage maintaining 19th century charm.

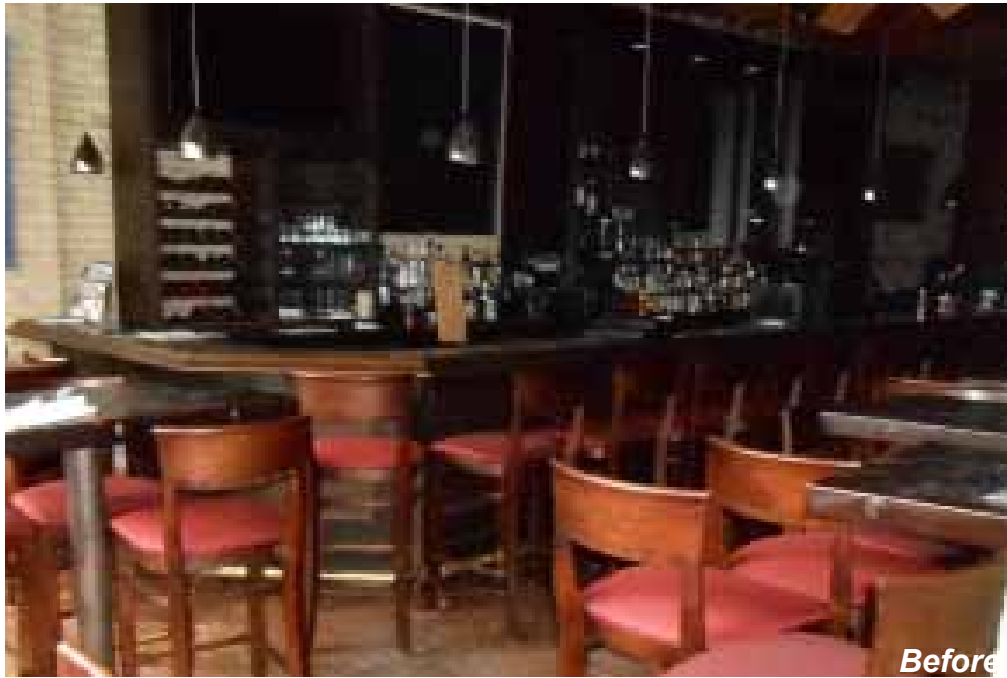
Before

The bar cabinetry and 8 ft high built in custom cabinets behind the bar proved to be a challenge. There was an uncanny air space behind so all cabinetry needed to be removed to address the smoke odor. Once carefully removed, we used baking soda to blast then sealed the brick and backside of the cabinetry. Restor-A Finish was applied over the existing espresso oak finish to return luster and rich charm.

Adding to the design and function, we integrated in top upper cabinetry can lights, audio visual equipment and automated lightning controls for the entire first floor. There were many electrical and code challenges associated with the updates and upgrades, but the Master Electrician was able to efficiently address and modernize the space to achieve the ambiance that was desired through custom lighting and music requests. A favorite of the bar staff are the glass beaded pendant lights, which are now on dimmers.

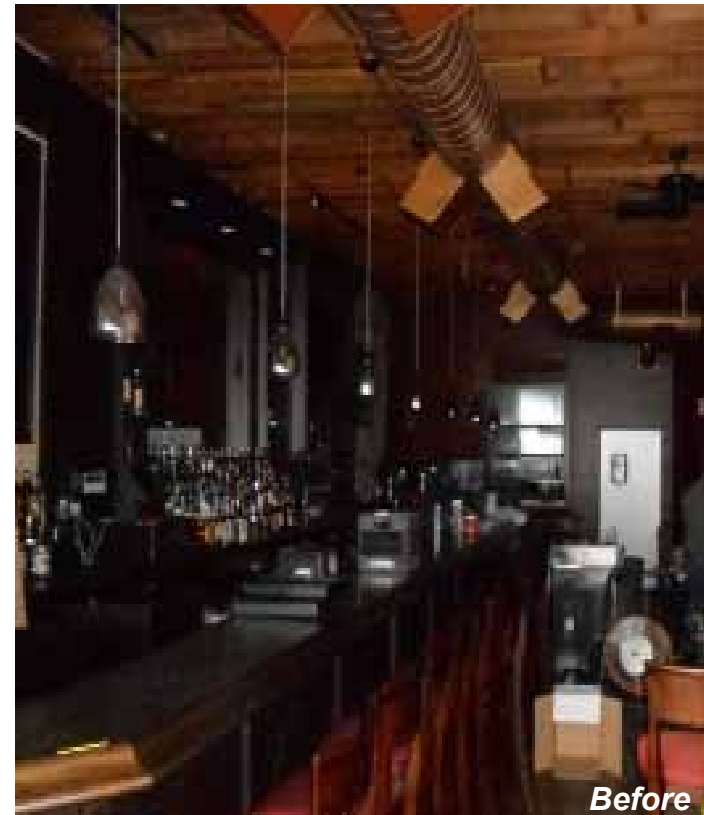
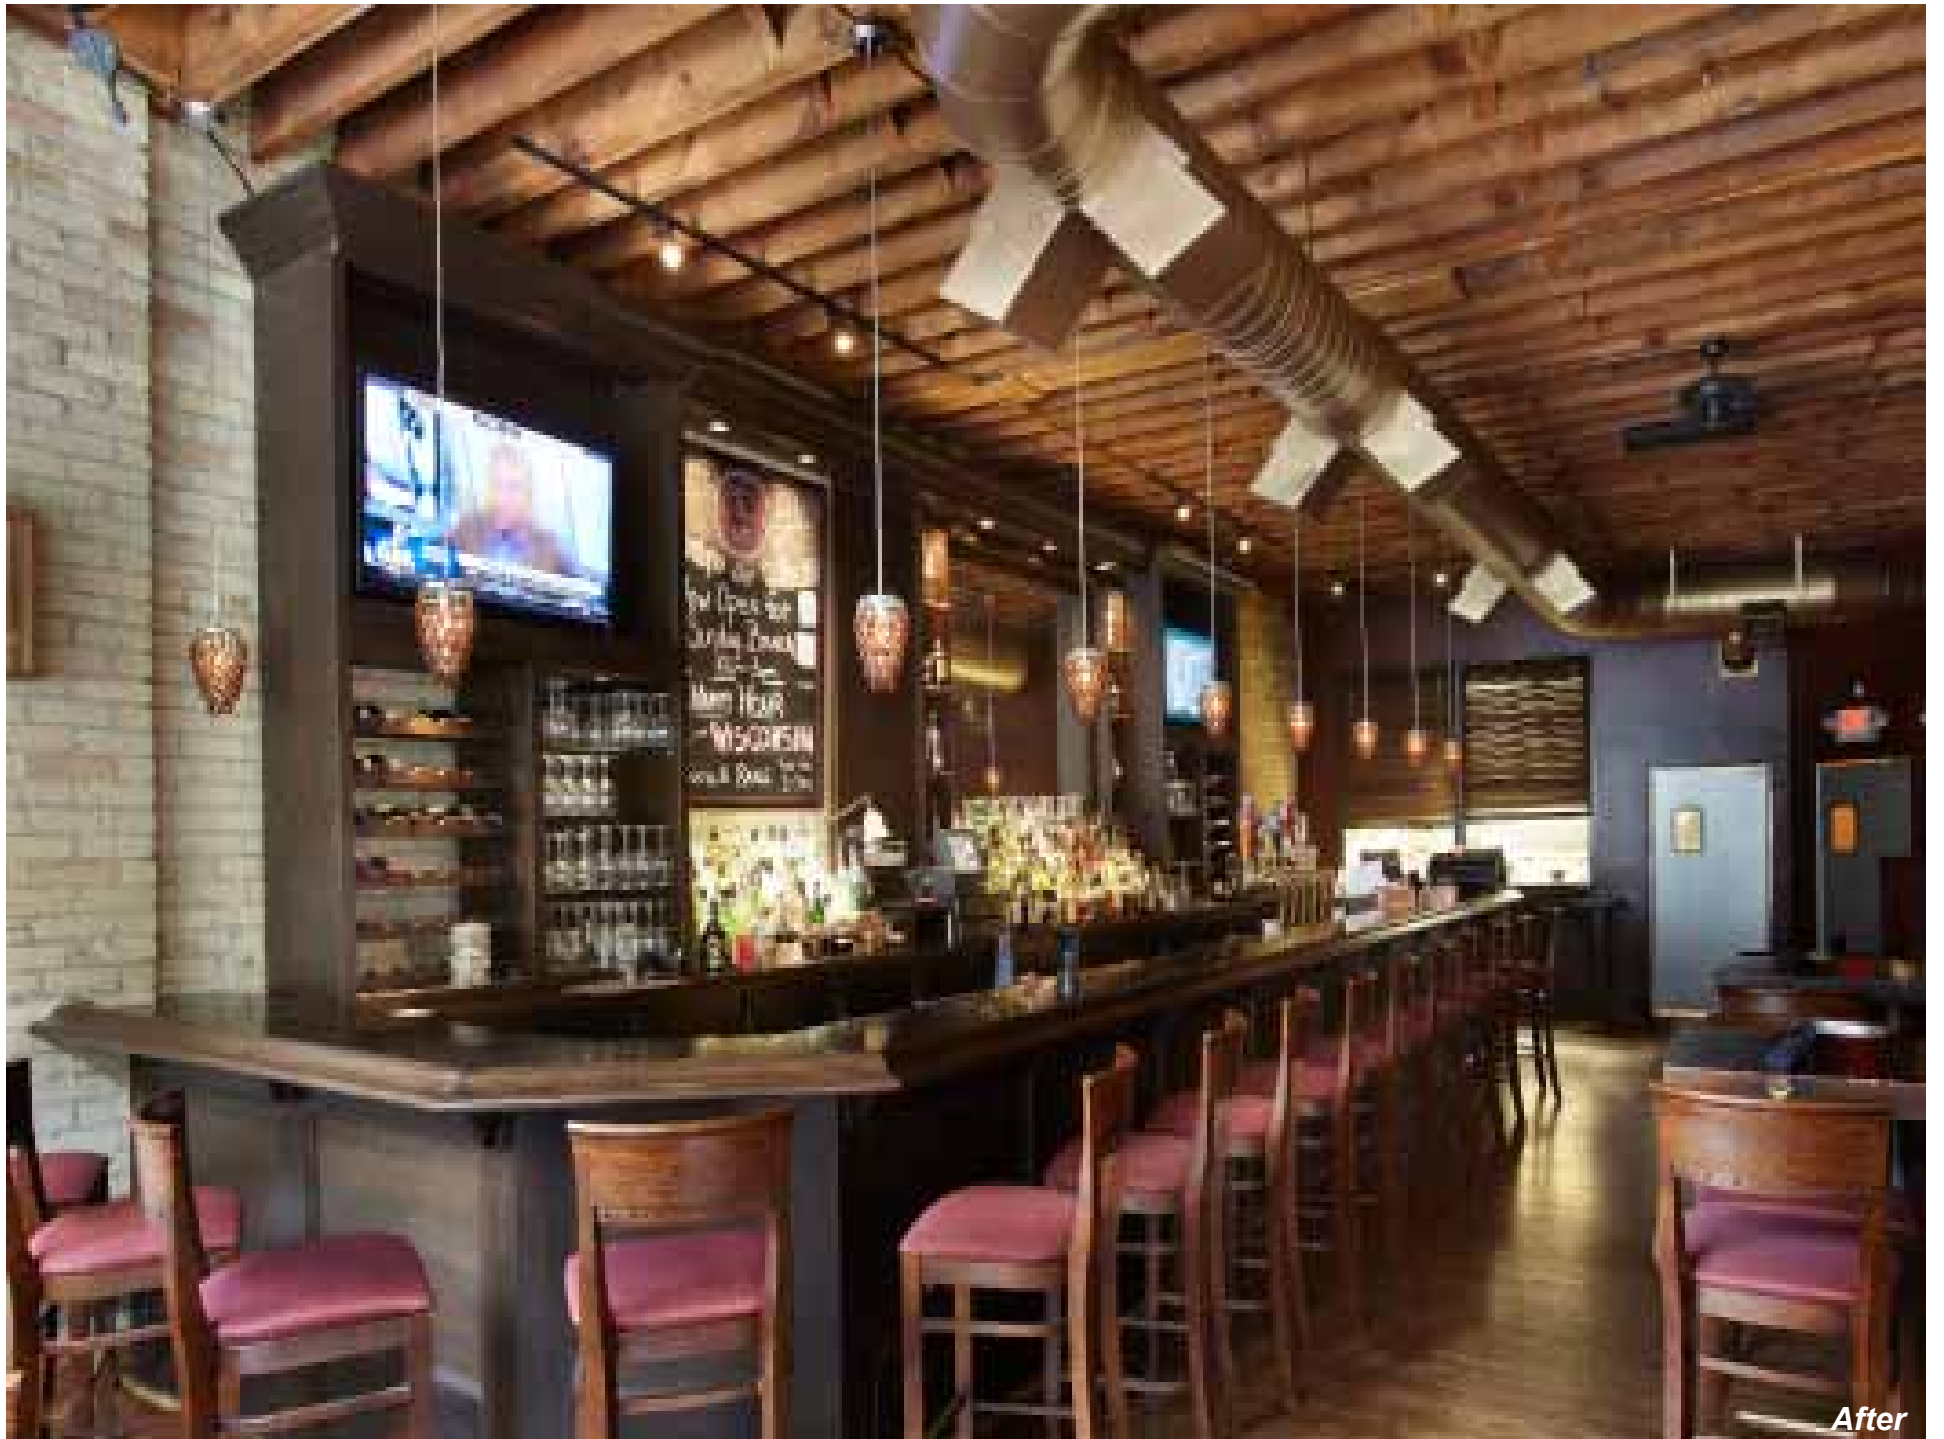
Soot puffs covered the beautiful cream city brick walls throughout the first floor dining room and bar area. Cream city brick is very porous and absorbs odors more than other construction materials producing a challenge to restore. These walls, and all other surfaces, required regimented and rigorous cleaning including soda blasting and special hand cleaning of all surfaces, visible and not. A careful approach was observed as not to compromise the very soft facade of the brick. This same attention and care was given to all contents from kitchen goods to dining chairs to restaurant linens.

A custom display shelf with lightning was added to compliment matching pieces in the formal dining room.

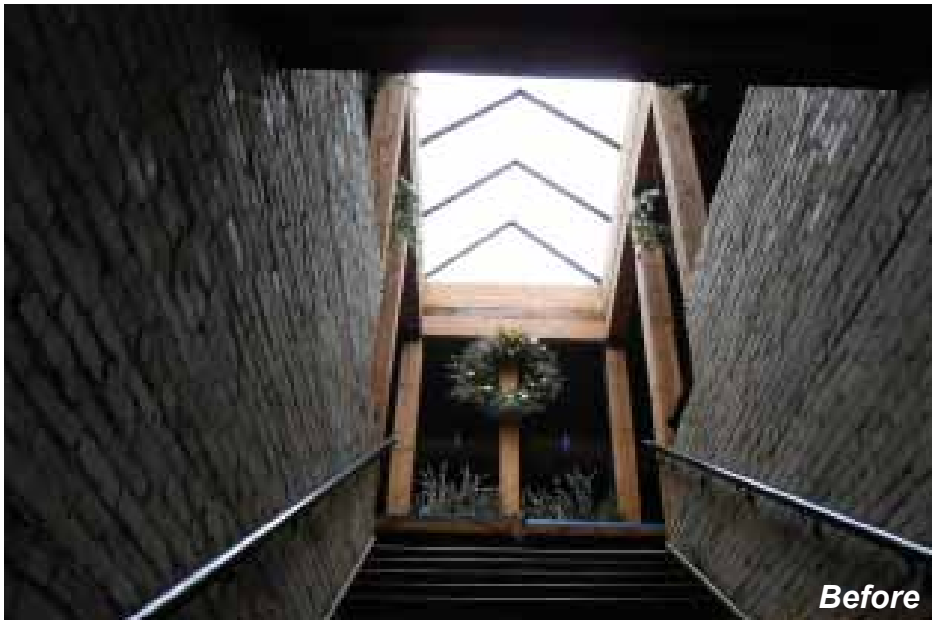
Tile was removed and reinforced beneath an existing structural condition that was discovered. In doing so, the new slate floor was gradually pitched making it safer for arriving patrons and staff as this is a high traffic corridor between the bar and dining room. The slate tile was a challenge as each piece required spalling to gain a consistent surface and lay appropriately in the pitch while observing ADA considerations.

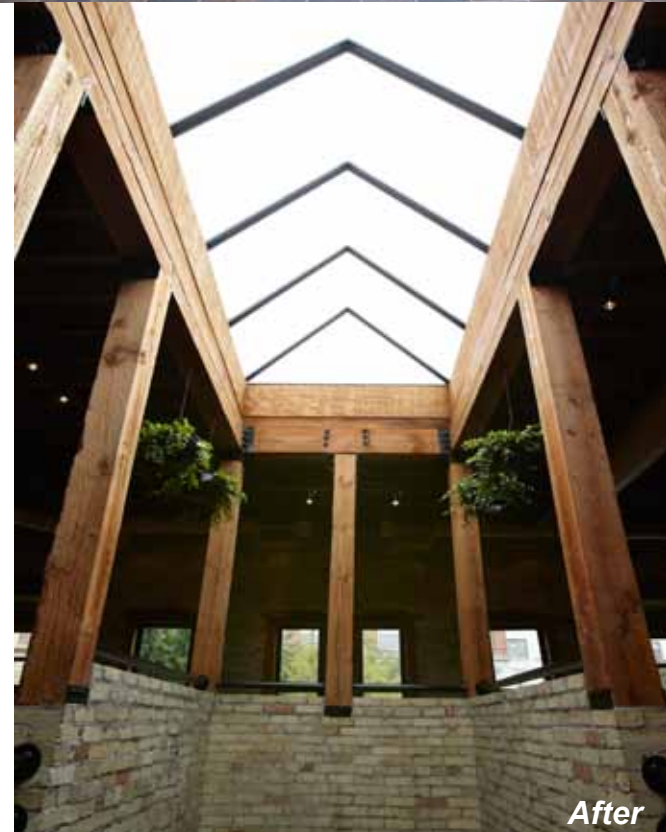
Grand Staircase:

A 10 foot wide staircase with atrium creates an impressive entrance, but also proved to be a challenge cleaning the expansive space with 14 foot ceilings from the second floor above the open stairwell. The right wall is an interior partition wall to the dining room and the left wall to the bar. Soot was particularly heavy due to the fire origin being below this space. The beautiful timber beams were cleaned and resealed with clear shellac.

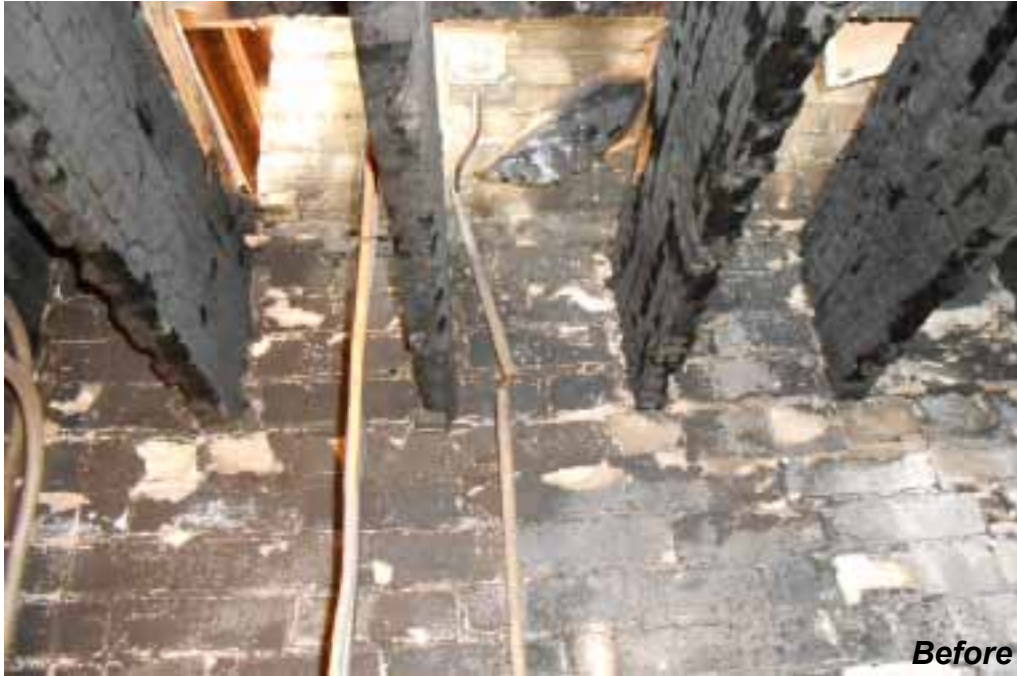
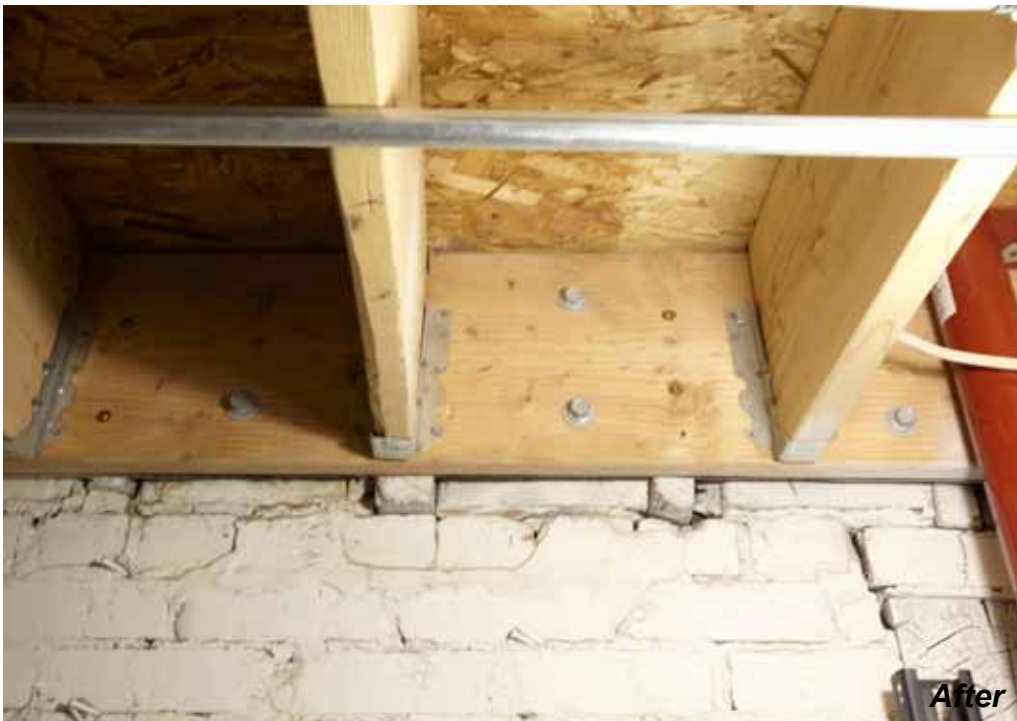
Structural Shoring:

The dining room floor joists were structurally compromised. Original 19th century construction pocketed them into the brick. They were cut flush and we established a ledger to attach new joists which are additionally supported by five new I-beams.

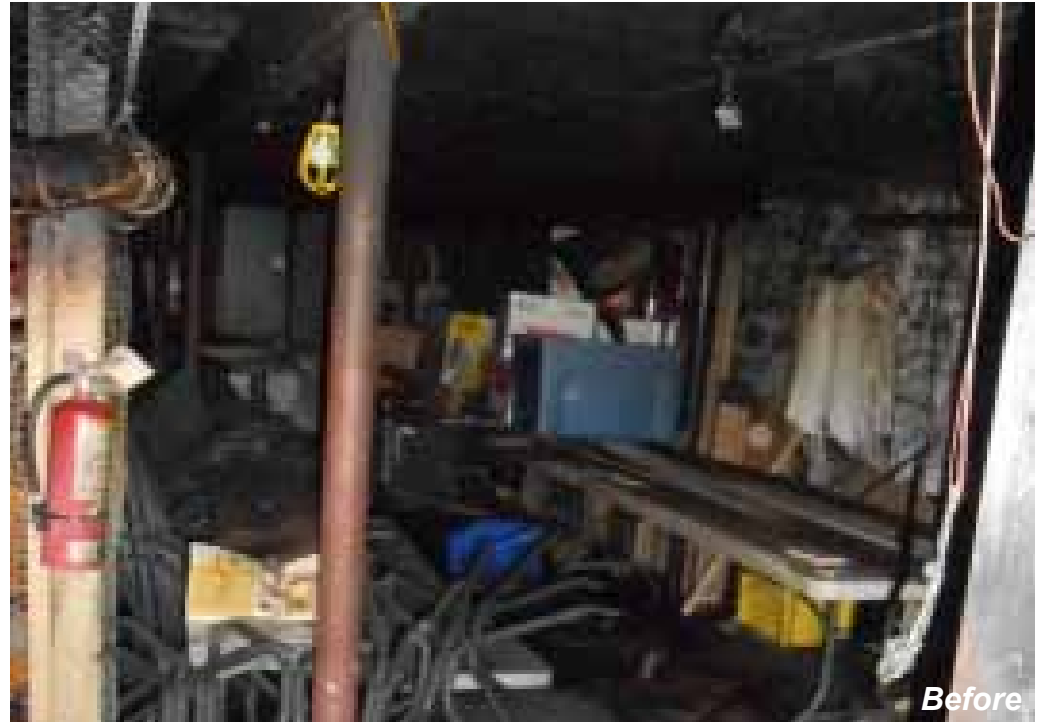
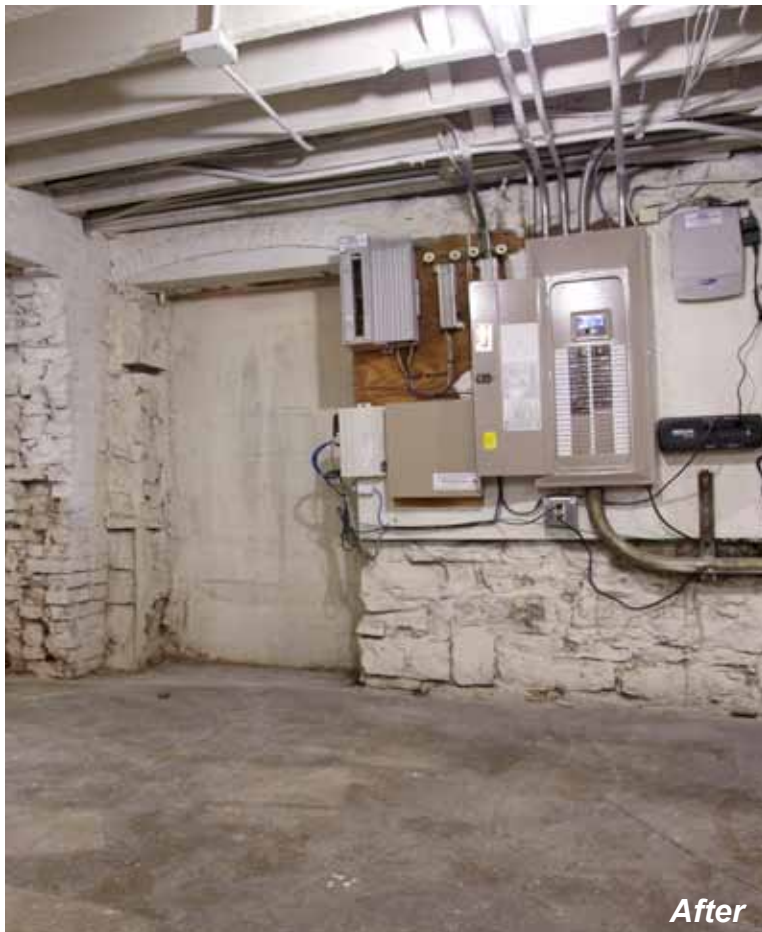
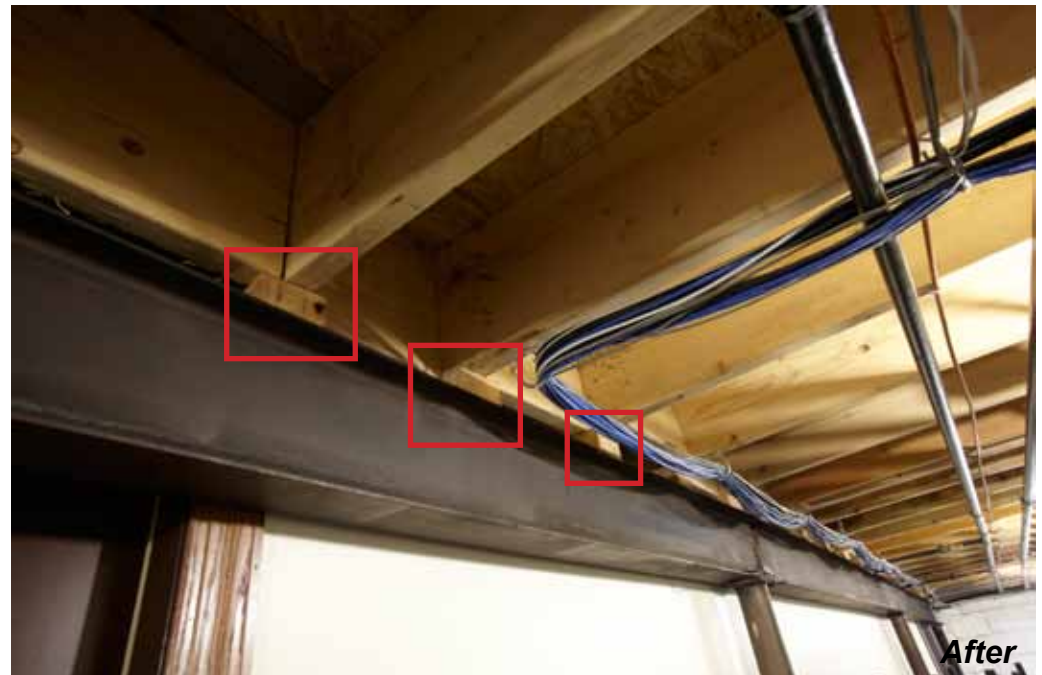
Basement:

The dining room had a drop ranging from a half inch to two and a half inches across the existing I-beam. Shims were innovatively used to correct the slope, see red boxes below.

In the basement, sealant was used to encapsulate any additional odor and refresh the space. The electrical system was updated throughout addressing both code and convenience factors.
